OAKFORD LAKE DAM
NJ 00544

PHASE 1 INSPECTION REPORT
NATIONAL DAM SAFETY PROGRAM

Philadelphia District
Corps of Engineers
Philadelphia, Pennsylvania

January, 1979

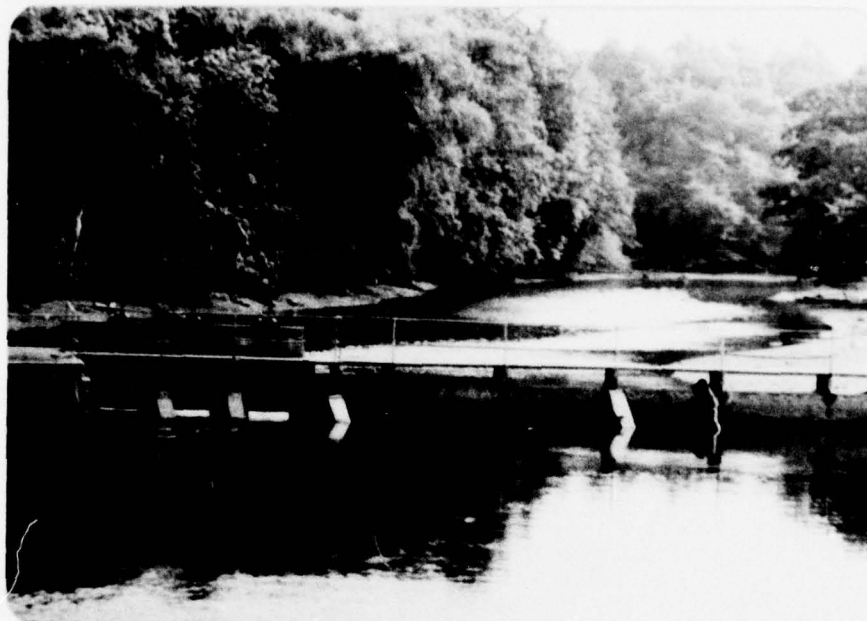
Photo 1 - View of downstream face of dam from Main Street Bridge. Note left gate that was damaged and could not be raised completely. (Photo taken September 7, 1978)

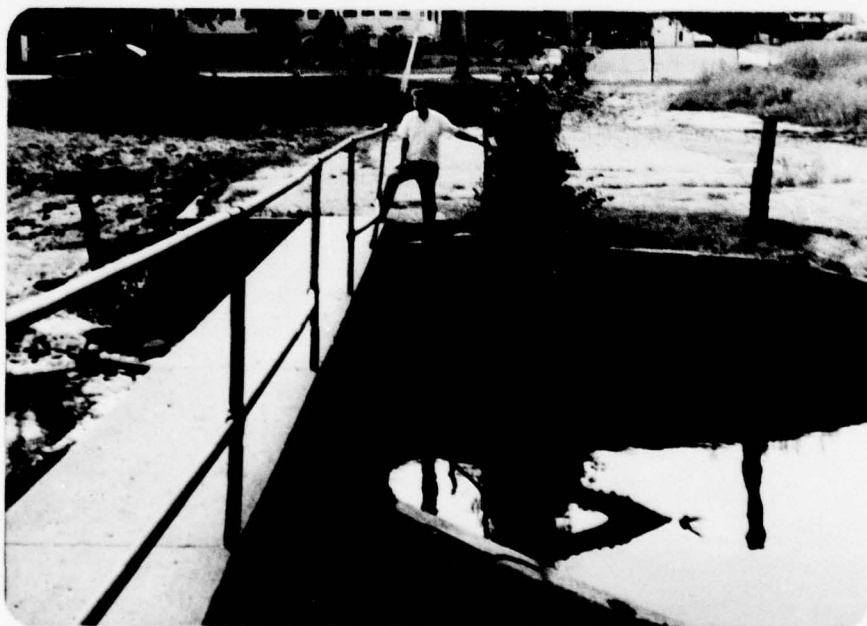
Photo 2 - View of concrete spillway and left abutment from low level outlet section. (Photo taken September 7, 1978)

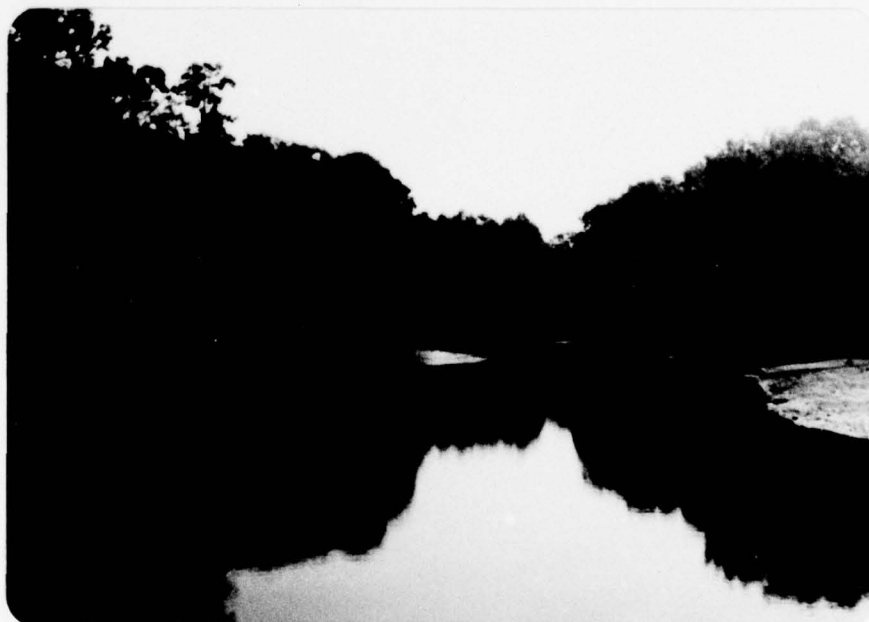
Photo 6 - View of reservoir from dam. Tree line is normal water level with gates closed. (Photo taken September 7, 1978)

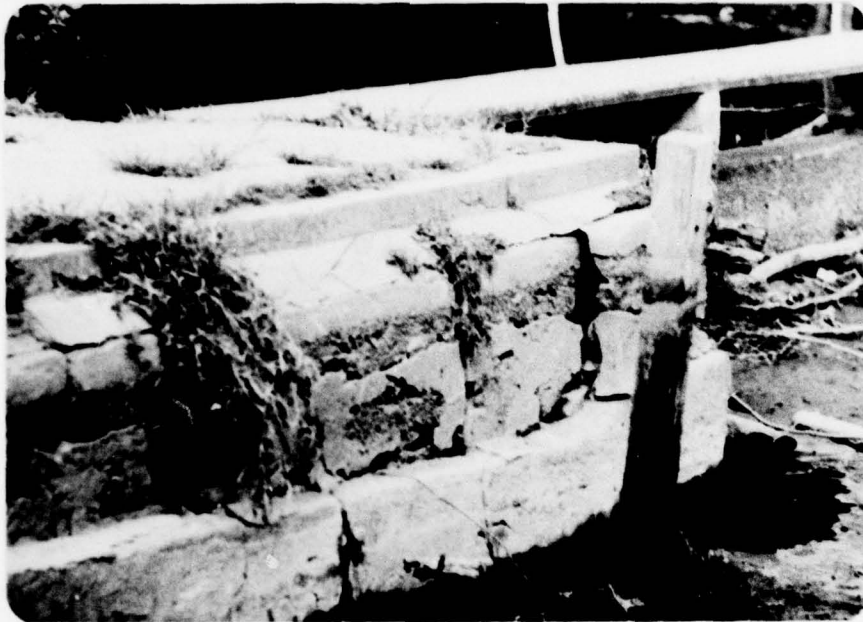
The stilling basin was under water and could not be observed. The concrete facing on the spillway left abutment and upstream wing-wall is severely deteriorated and missing. The facing on the upstream side of the abutment is completely missing, exposing the timber piling and fill material.

Photo 7 - Upstream face of left abutment showing missing and deteriorated concrete facing. (Photo taken September 7, 1978)

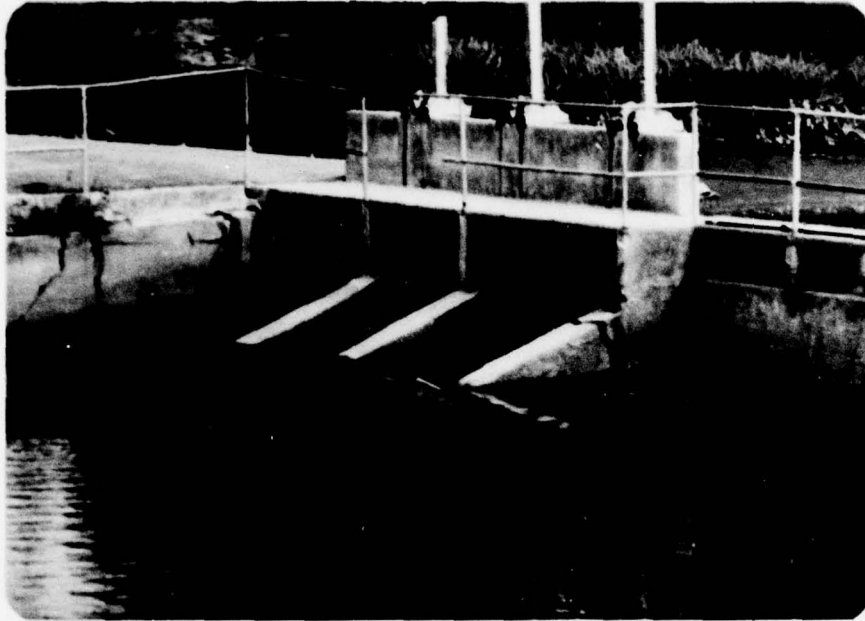
The concrete of the low level outlet section has spalling on both the upstream and downstream faces. The left buttress has a structural crack running down through the footing. At the time of inspection, the separation was approximately 3-inch wide, which according to local officials is wider than what it was before the flood of August 1978 hit the area. The crack appears to be caused by undercutting of the footing and the

resulting settlement of the buttress. Probing the streambed area left of buttress footing, revealed the bottom to be 3 to 4-foot deeper than that at the end of the stilling basin. The stilling basin was under water and could not be observed but probing the area seems to indicate the basin is cracked as shown on the reconnaissance sketches (Figure 2).

Photo 9 - View of downstream face of low level outlet section showing cracked left buttress. Also note cracked abutment wall to the left. (Photo taken September 7, 1978)

- b. Within eighteen months repair the cracked buttress and stilling basin at the low level outlet sections.
- c. Within eighteen months fill in the area downstream of the concrete weir with heavy riprap stone to prevent scouring.

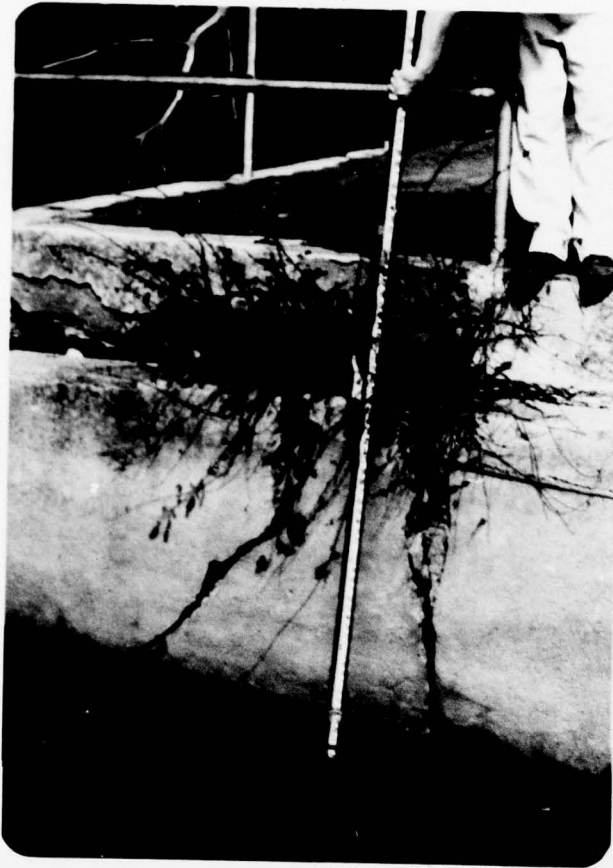
The dike portion, approximately 85-foot long, extends from the low level outlet section to the right bank and has vertical concrete facing 6-inch thick over a timber structure. The top of the dike, which varies from 20 to 24 feet in width is paved with 3 to 4 inches of asphalt. The concrete facing on the dike section has cracked and deteriorated extensively on the upstream face and channel side by the low level outlets. On the channel side of the dike, the damage to the concrete facing is such that the space between the cracks, in some cases is 2 inches or greater, and the entire corner of the downstream face has washed away.

Photo 11 - Cracked concrete facing of right abutment dike on discharge channel side. (Photo taken September 7, 1978)
